WATER DAMAGE ASSESSMENT

**Massachusetts Rehabilitation Commission
6 Clinton Avenue
Pittsfield, Massachusetts**

Prepared by:
Massachusetts Department of Public Health
Bureau of Environmental Health
Indoor Air Quality Program
January 2020

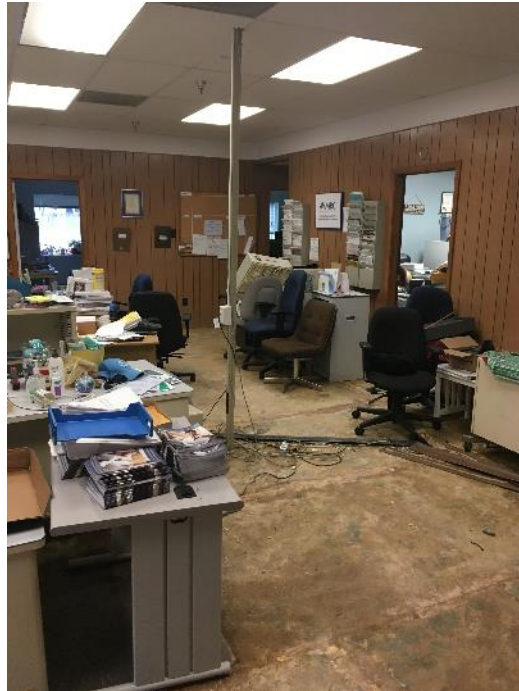
Picture 1

Over the weekend of December 20, 2019, a water pipe burst, wetting the majority of occupied space in this office (Picture 1). Following the discovery of this flooding event, a disaster remediation contractor was retained to begin remediation. The following activities were conducted:

Water-damaged office floor

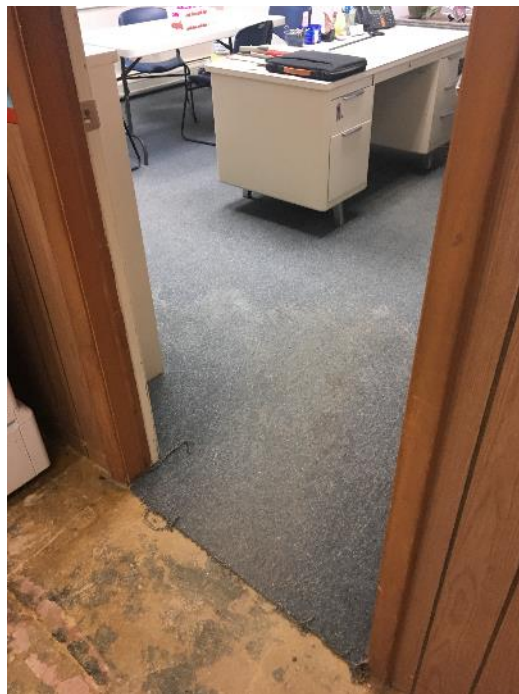
Picture 2

- Carpeting in a number of areas was left intact (Picture 2);

Intact carpeting in an office

- a. Inspecting and cleaning the floor cavity;
 - b. Removing all floor covering materials throughout the MRC offices; and
 - c. Removal of all mold-contaminated flooring materials.

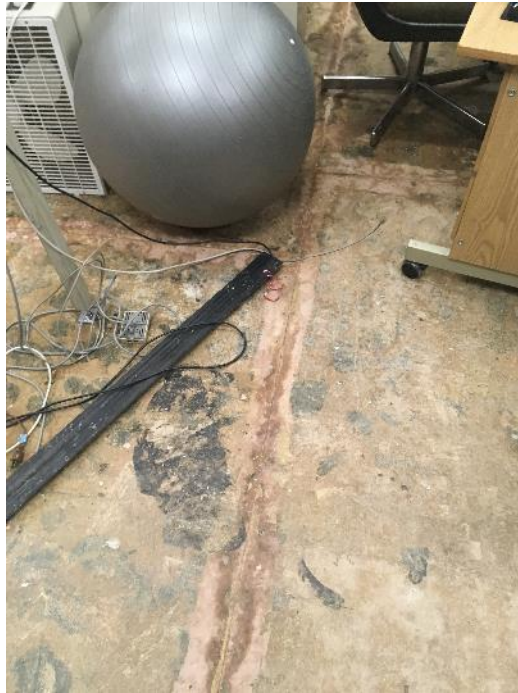
Picture 3

During the course of this assessment, IAQ staff noted that the spaces between wood sheets composing the exposed under-flooring were darkened (Picture 3). In the experience of IAQ staff, such darkening is consistent with the wood becoming moistened by water/water vapor trapped within the floor cavity, which indicates the under-flooring, and supporting 2x4s, were continuously moistened from December 20 to December 27 for over 160 hours. In general, the US EPA recommends beginning drying strategies “to respond to water damage within 24-48 hours” (US EPA, 2008). It is important to note that “[i]f mold growth has occurred or materials have been wet for more than 48 hours, consult Table 2 [Mold Remediation Guidelines]. Even if materials are dried within 48 hours, mold growth may have occurred” (US EPA, 2008).

IAQ staff conducted moisture sampling of darkened wood sheet floor seams as well as existing carpet. Both wood floor seams and carpeting had elevated moisture measurements, indicating that a significant water source exists in the floor cavity throughout the MRC office space that was moistening both floor wood and carpeting.

Dark stain at seam

3. Remediate and investigate conditions in the floor cavity in a manner consistent with US EPA guideline “Mold Remediation in Schools and Commercial Buildings” (US EPA, 2008). This may include:
